# MEMORANDUM

Date: September 13, 2023

From: Peter Winch, WRT

Project: Tiburon Parks and Recreation  
Master Plan

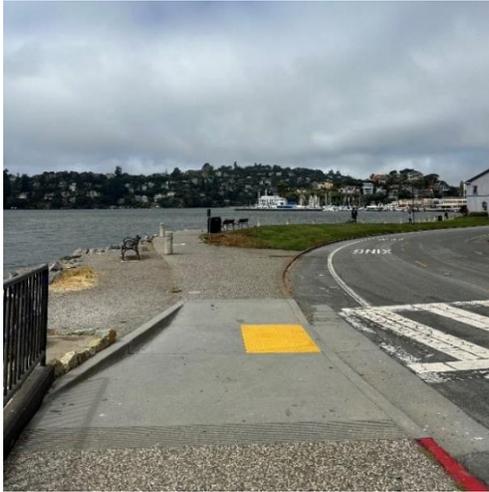
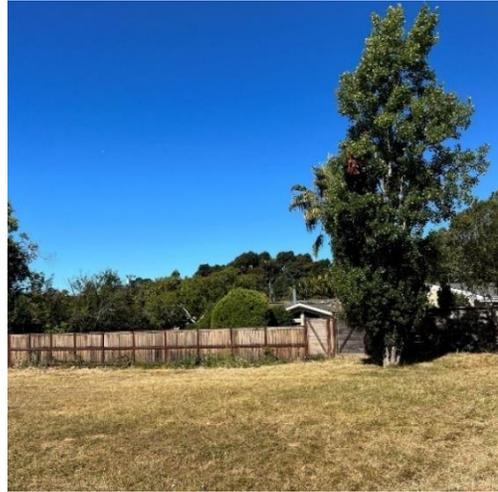
*Shoreline Par (left), is well-connected to pedestrian and cycling routes, and is. Bel Aire Park (right), is blocked from the surrounding areas by fencing and not connected to strong bicycle and pedestrian networks.*

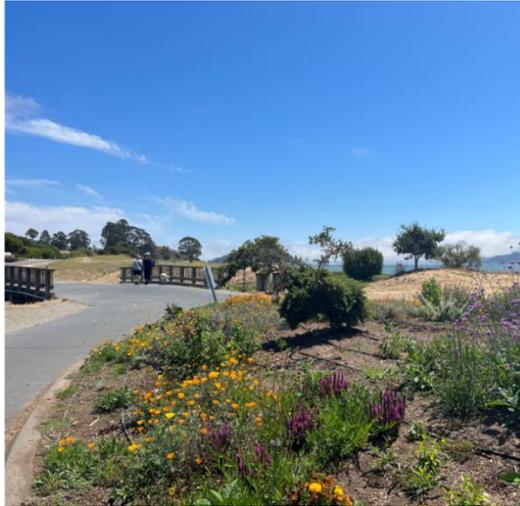
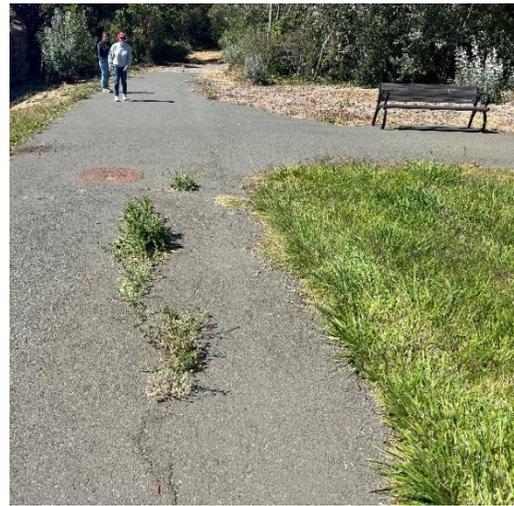
*Landscaping, paths, and all available amenities—bathroom, trash receptables, seating, water fountain, bike repair station—are all in great condition at Blackie’s Pasture (left). Benches are in good condition; paving and landscaping are in okay condition at Belveron Mini Park (right).*

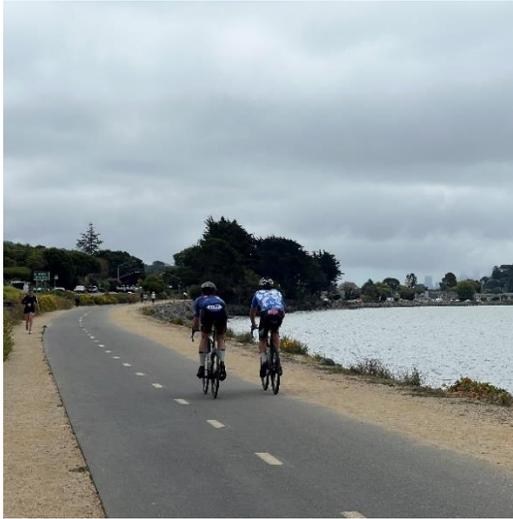
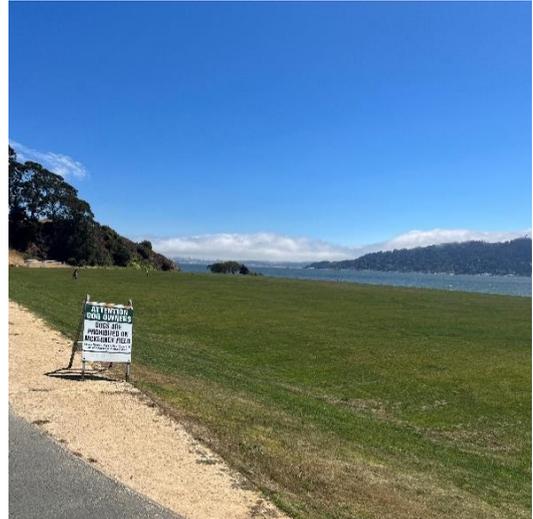
*The trail is very well-used for a variety of activities (Old Rail Trail, left). Although McKegney Green functions very well as an organized sports field, it is single-use and lack shade and amenities that would improve the spectator experience (McKegney Green, right).*

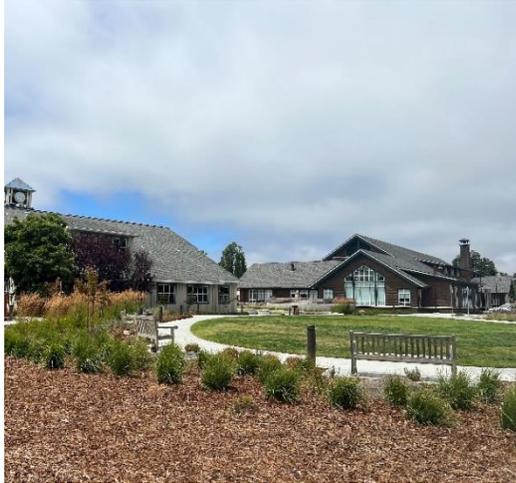
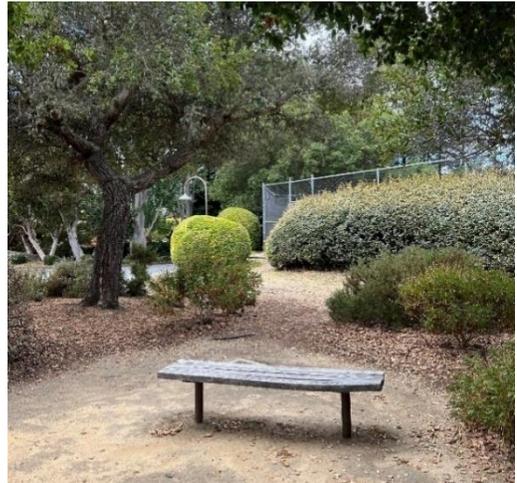
*Zelinsky Park, left, is surrounded by community hubs with clear lines of sight throughout. There is ample lighting. Teather Park, right, is secluded and does not have good lines of sight.*

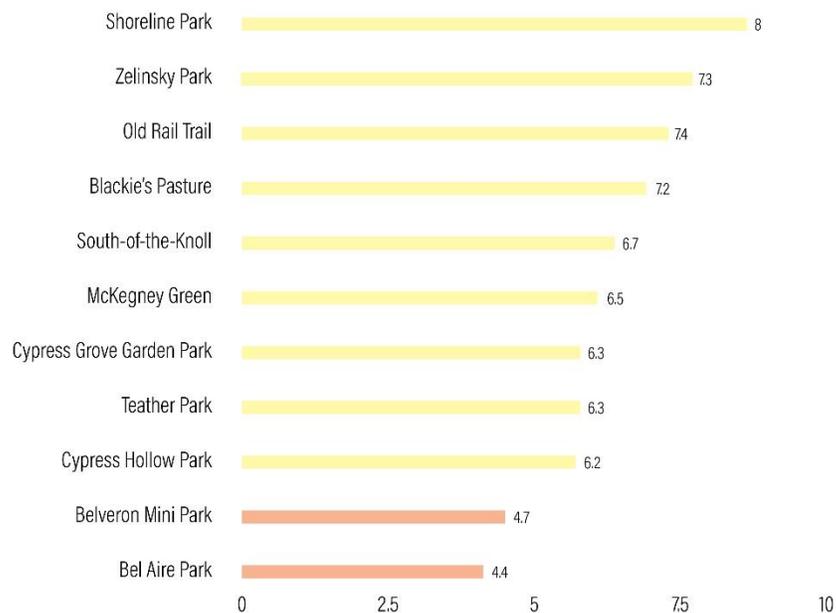
**Chart 5: Parks Overall Score Summary**

Tiburon’s parks are well-used and functional. The majority of the parks scored within the “Good” range and no parks scored in the “Poor” range. Lower-scoring parks in our assessment would benefit from the addition of neighborhood-oriented recreational functions and clearer identity and visibility.
